BOOST *Makeover*

The Teardown

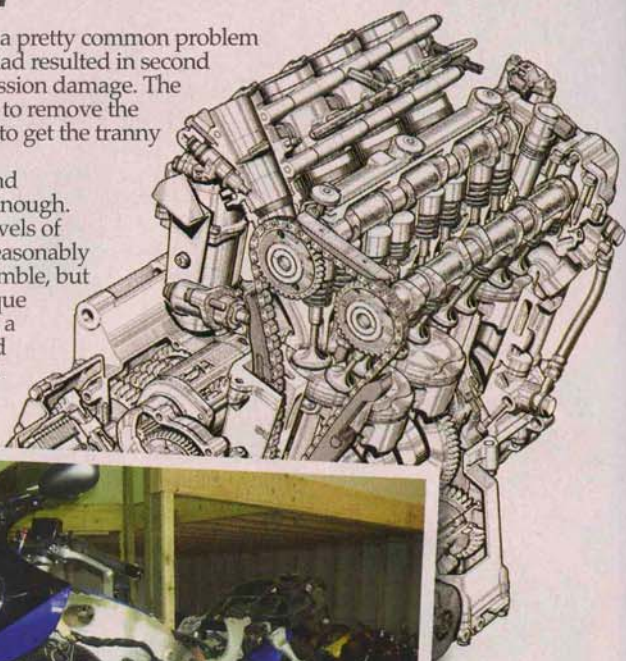
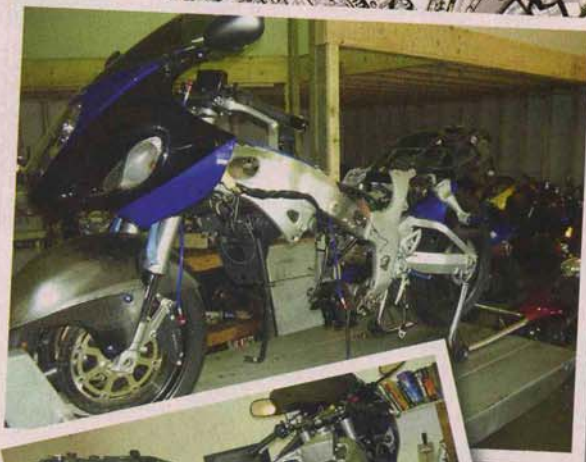
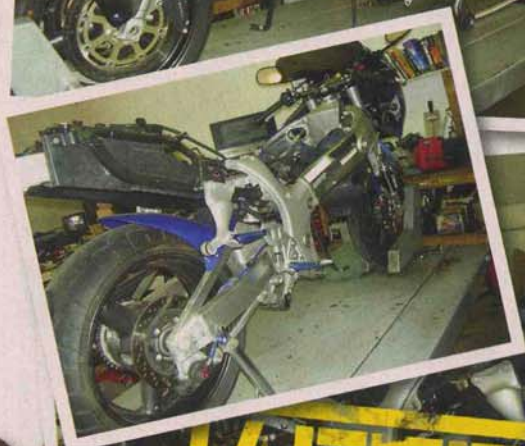
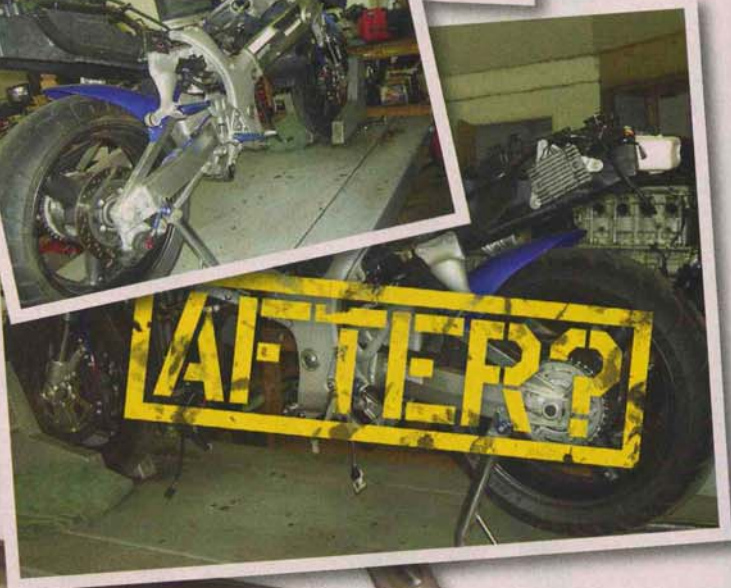
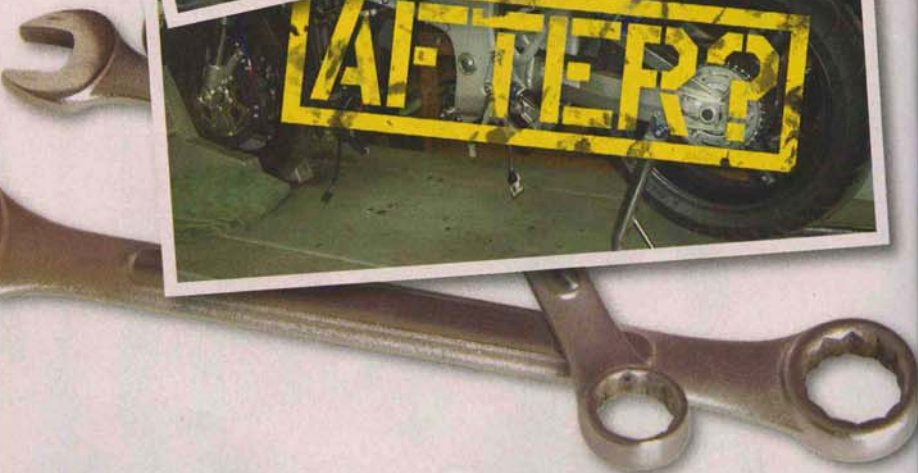
The 'Busa Bill used had a pretty common problem going in – wheelie antics had resulted in second gearshift fork and transmission damage. The first order of business was to remove the engine and disassemble it to get the tranny out.

Removing the engine and tearing it down is simple enough. Hayabusa motors are marvels of modern technology and reasonably straightforward to disassemble, but there are hundreds of unique bolts and small bits. Using a factory service manual and careful labeling of all parts during disassembly is crucial.
